**GOVERNMENT OF BERMUDA
MINISTRY OF TOURISM DEVELOPMENT AND TRANSPORT
DEPARTMENT OF MARITIME ADMINISTRATION**

**REPORT OF INVESTIGATION INTO THE DEATH OF A PASSENGER
ON BOARD THE SHIP "QUEEN ELIZABETH" INVOLVING
A SHIP'S TENDER
1ST APRIL 2015**

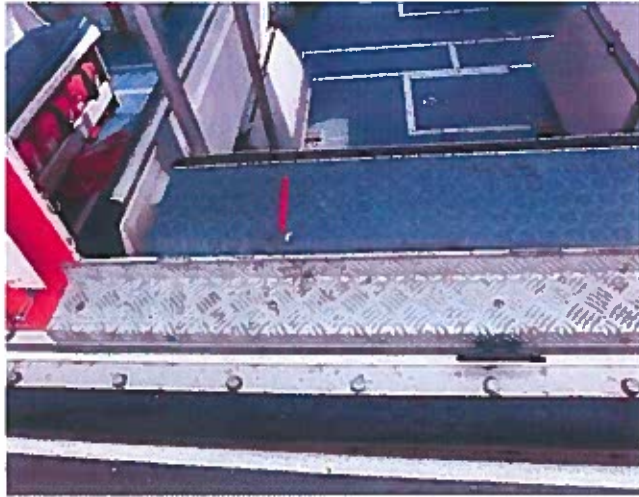
On Tender 16, the top step at the entrance door on the Starboard side is 26 cm wide, whereas other tenders on the vessel have wider platform as the top step.

The photo above shows the width of the step in question on Tender 16, a pencil has been used to compare and estimate the width of the top step.

assisting her on to the top step. She was unsteady and had difficulty in balancing herself on the narrow top step. The one crew member from the pontoon was also trying to assist the passenger, this operation was being watched by the safety officer who was standing on the pontoon. Taking into consideration the uncertain movements of the tender and the known mobility difficulties of the passenger, the disembarkation process should have been stopped, until appropriate safe conditions were established.

- i) Whilst acknowledging that it is non-contributory to the accident the existing top step of the tender step ladder of Tender No.16 is too narrow, Carnival UK must ensure the tenders are provided with a wider passenger landing step to afford the passengers a steady and balanced footing, for safe stepping out from the tender;

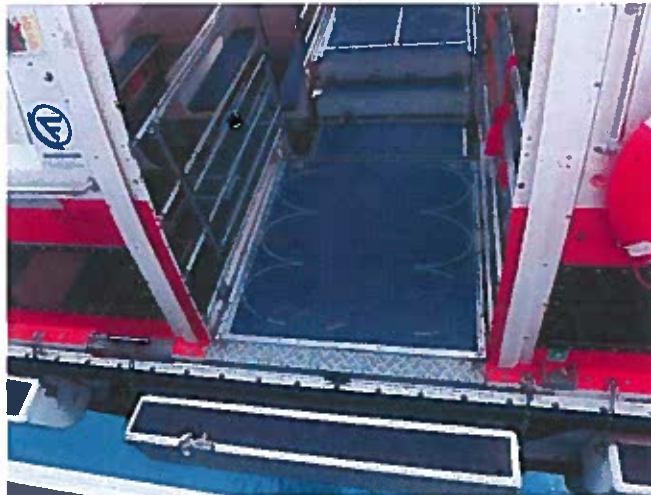
The photo above shows the step arrangement in the other tenders, it is a much wider platform.
